**TO:** Larry Gremminger, Christopher Embry – Sunoco Pipe Line Project/Energy Transfer  
**FROM:** David Demko PG – Groundwater and Environmental Services, Inc. (GES)  
**CC:** Lieschen Fish PG, Rick Wardrop, Stephanie Grillo – GES  
**DATE:** November 7, 2019  
**PROJECT NAME:** ME2 – Spread 6 – HDD S3-0360-16 (Devon Rd/ Shoen Road 16-inch pipeline, PA-CH-0199.0000-RD)  
**SUBJECT:** Restart Report for Groundwater Flowback Discharge at HDD S3-0360-16

This Revised Restart Report has been amended to respond to verbal and email comments/requests for information from the Pennsylvania Department of Environmental Protection (PADEP) to the initial report dated October 21, 2019. The initial report was prepared in accordance with the terms and conditions of Paragraph 3.h. of the Consent Order Agreement between Sunoco Pipe Line Project (SPLP) and the PADEP dated July 24, 2017, concerning drilling operations at HDD S3-0360-16 (Devon Rd/ Shoen Road). This Revised Restart Report proposes changes in HDD operations to mitigate groundwater flowback that occurred at varying rates as the drill was advanced.

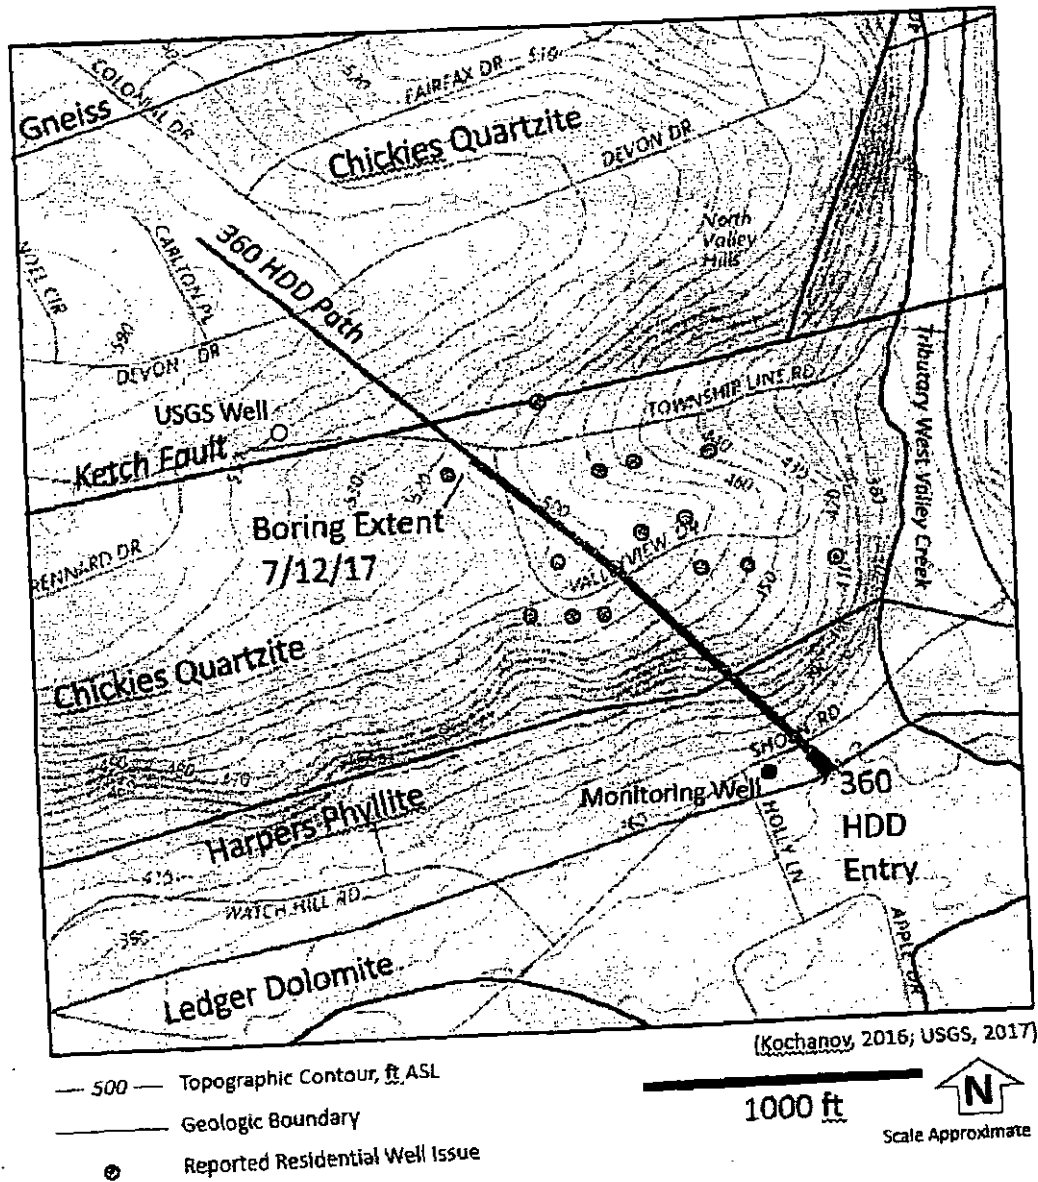
Figure 1. Site geology and hydrology of the S3-360 HDD boring.

Based on geologic maps, the site is located in the uplands along the northern edge of Chester Valley. As shown on Figure 1, the completed HDD will advance northeast through the Harpers Phyllite and partially into the Chickies Quartzite. A contact between the Chickies and gneiss occurs north of the northwest exit/entry point. The valley floor, southeast of the low end entry point is composed of carbonates, including the Ledger Dolomite. A major fault, named the "Ketch Fault," bisects the Chickies. The geologic structure in this area is complex and the location of the contacts, as shown on geologic mapping, may lack accuracy. For example, a monitoring well was installed at the location shown on Figure 1. The log for that well shows limestone where one would expect Harpers Phyllite. Also, a recent geotechnical boring drilled near the south entry/exit was most likely in karst as the boring went 130 feet before encountering bedrock.

Typical depth to groundwater in the Chickies Quartzite uplands is approximately 40 ft, as indicated by a residential well monitored by the USGS and reported by Low et al. (2002). The source of groundwater is direct recharge from precipitation and regional flow from the west. Groundwater in the vicinity of the 360 HDD path is expected to flow east along the fabric of the bedrock and south toward tributaries of West Valley Creek.

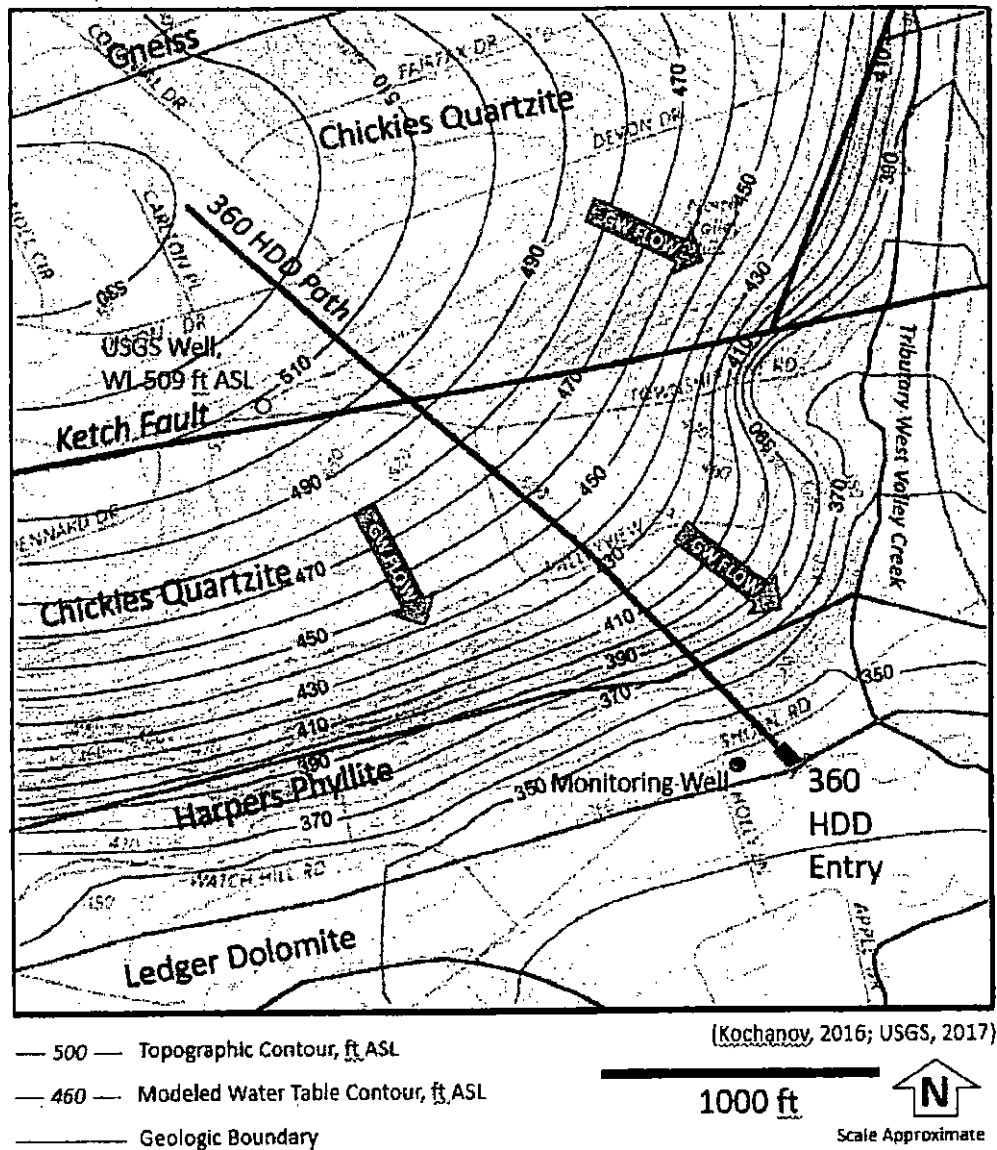
**Figure 2.** Computer-simulated water table under natural, pre-construction conditions.

The model-generated water table corroborates the conceptual site model, showing groundwater flowing toward the southeast in the vicinity of the 360 Drill path (Figure 2). The water table is approximately 40 ft below ground surface along Valleyview Drive. For this simulation, recharge was specified at the rate of 0.0042 ft/day reported by Senior et al. (1997). Model calibration predicted a Chickies hydraulic conductivity ( $K_h$ ) of 0.16 ft/day. This is similar in magnitude to the median K value of 0.32 ft/day reported by Low et al. (2002).

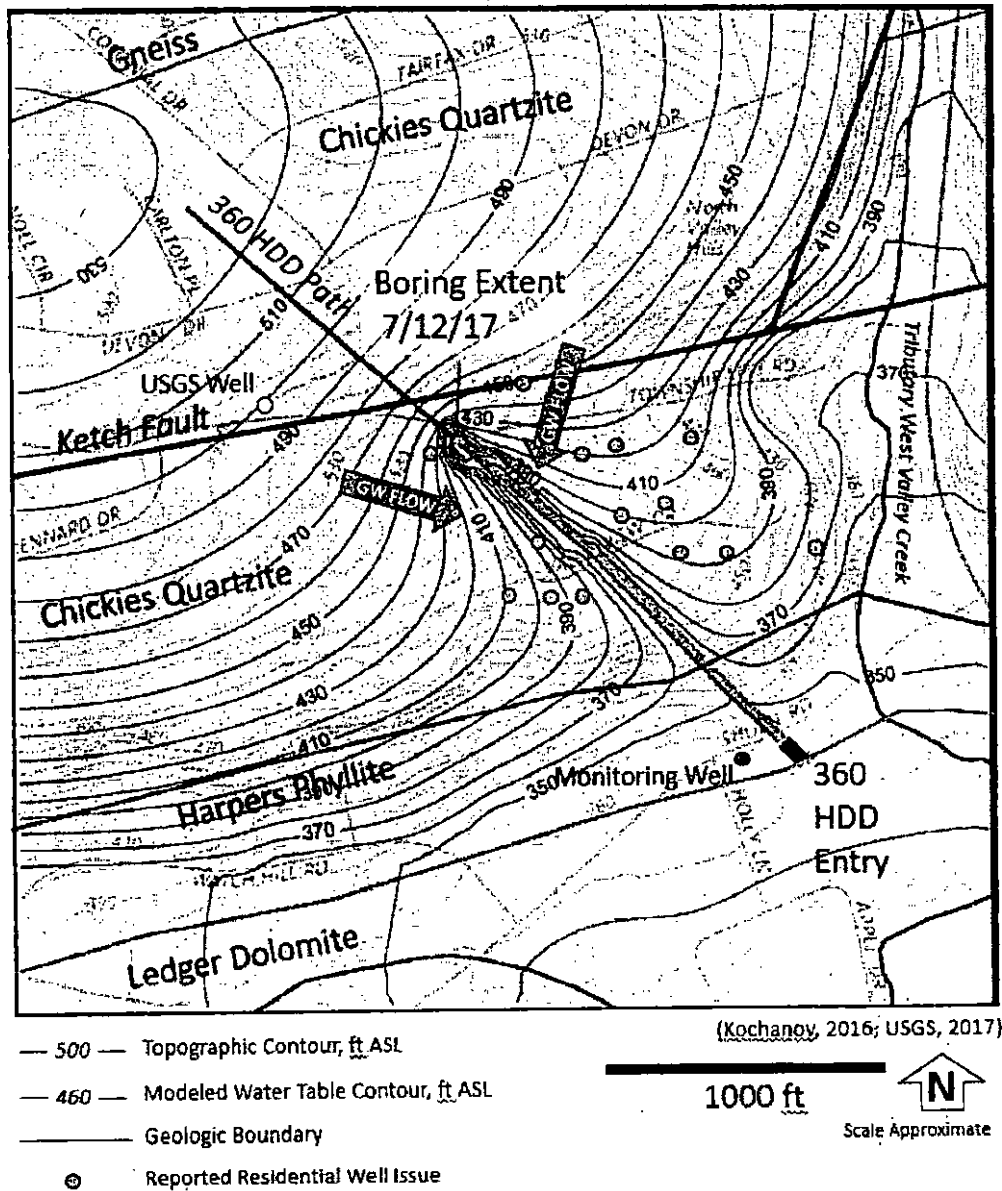
A drain (groundwater zone of depression) was placed within the model to simulate the effect of groundwater discharge produced by the pilot hole at a distance of 1,575 ft. from entry (Figure 3). Discharge from the pilot hole lowers the water table, forming a "depression" in the groundwater associated with the Valleyview Dr./Township Line Rd. neighborhood. In this simulation, groundwater migrates toward the pilot hole (indicated by the groundwater flow arrows) and discharges from the pilot hole at a rate (Q) of 43 gpm, which is very similar to the groundwater flow reported by field personnel at the drill entry point. Figure 4 represents the simulated change in water level from the pre-construction condition shown in Scenario 1 to conditions present on 7/12/17 when the pilot hole was advanced to 1,575 ft.

**Figure 3.** Simulated effect to water table after pilot hole was advanced to 1,575 ft, from entry, showing a trench-shaped depression above the pilot hole. Input parameters  $R = 0.0042$  ft/day, Chickies  $K_h = 0.16$  ft/day.

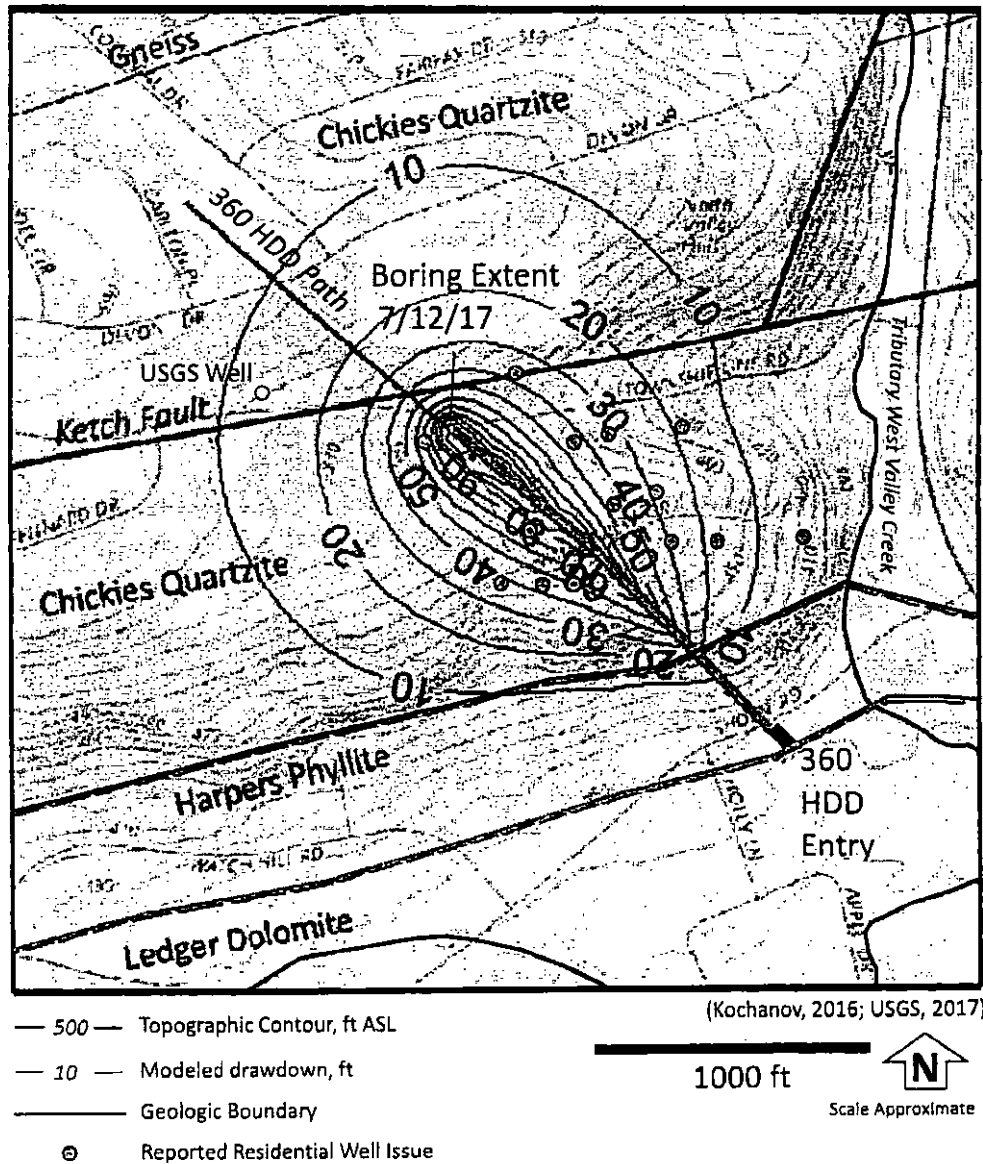
To evaluate the extent of potential impact of the HDD 360 Drill during construction, a map of *drawdown* (vertical distance the water table might have been lowered) was produced by plotting the difference in water levels between Scenario 1 and Scenario 2 (Figure 4). The maximum predicted drawdown is 130 ft near the northwest end of the pilot hole. This simulation reveals that the zone of influence in water table drawdown (here assumed to be 10 ft of drawdown or greater) may have extended up to 1,000 ft. from the path of the 360 Drill. Most, but not all, of the residential wells reported to have had issues are located within this zone.

**Figure 4.** Simulated drawdown (lowering of the water table) during pilot hole advancement, indicating that the pilot hole may have lowered the water table 130 ft. Aquifer drawdown potentially extended 1,000 feet away from the path of the 360 Drill. Input parameters  $R = 0.0042$  ft/day and Chickies  $K_h = 0.16$  ft/day. Simulated flow rate of produce groundwater is 43 gpm.

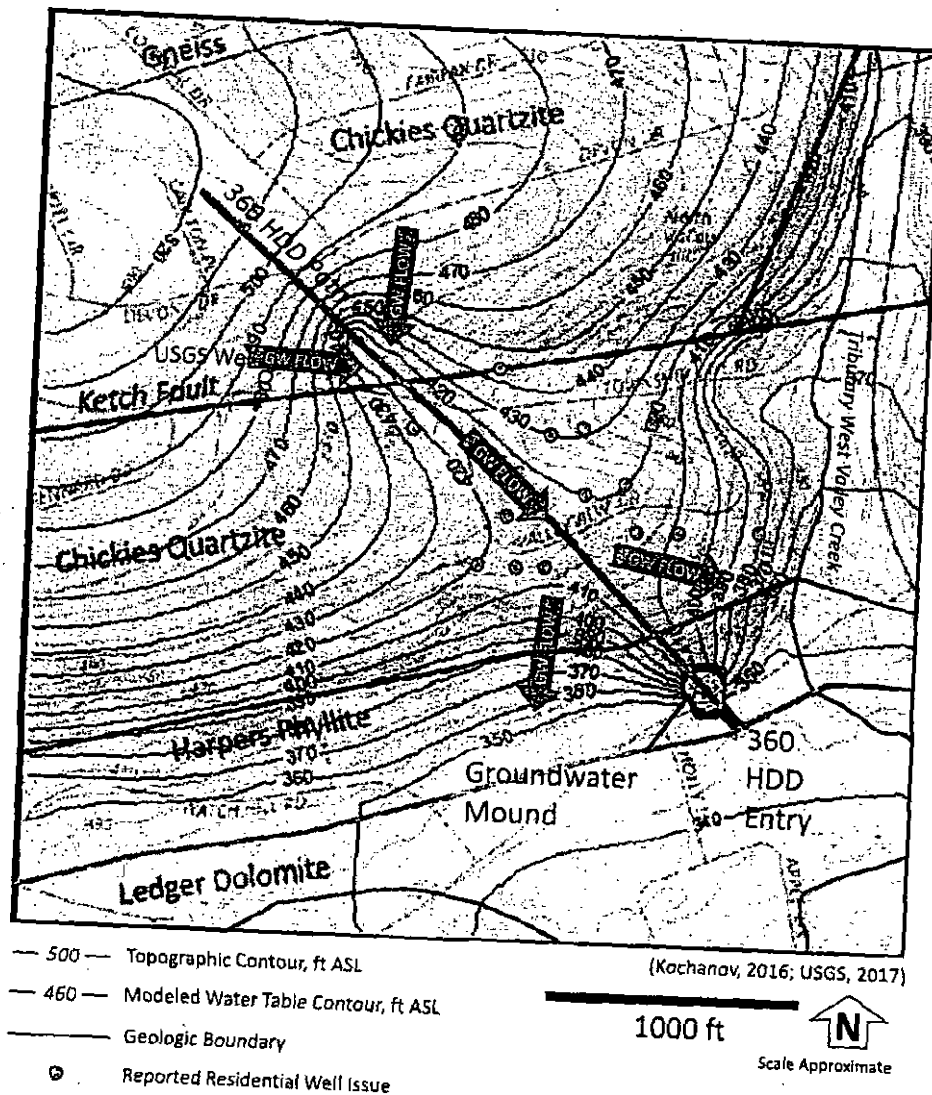
The model simulation suggests that groundwater would flow toward the drill hole in the northwest, through the assumed open annular space in the drill hole, then away from the drill hole near the southeast terminus (Figure 5). Subsequently, a groundwater mound would develop which could generate seeps north of Shoen Rd., similar to what was observed on July 20, 2017 in response to attempts to grout the open drill hole, and reportedly continues currently to produce surface seepage at that location.

**Figure 5.** Groundwater flow response for Scenario 3. The annular space drains groundwater from uphill and creates a groundwater mound that produces seeps on the hillslope.

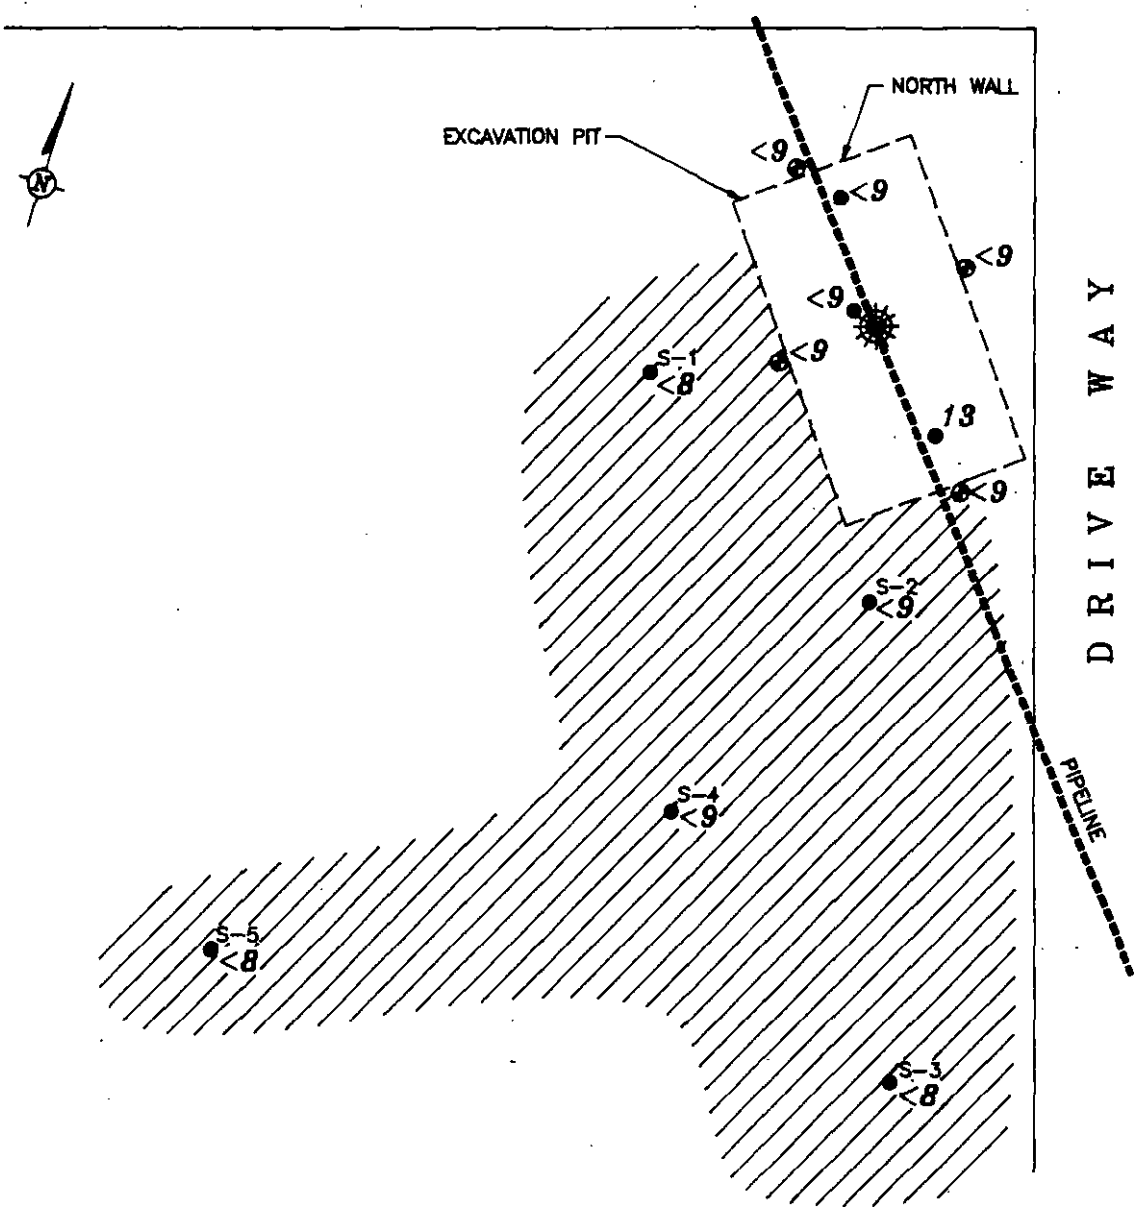
# SHOEN ROAD

In addition, approximately 400 cubic yards of topsoil were removed from the grassy slope impacted by the leak. The topsoil was excavated to an average depth of 1 foot through the entire affected area. Five soil samples were collected upon removal of the topsoil. The sample locations, shown on Figure 1, were labelled S-1 through S-5.

Based on the soil sampling results and the favorable soil conditions, Geraghty & Miller recommends that the soil excavation site be backfilled with clean material and restored as soon as possible.

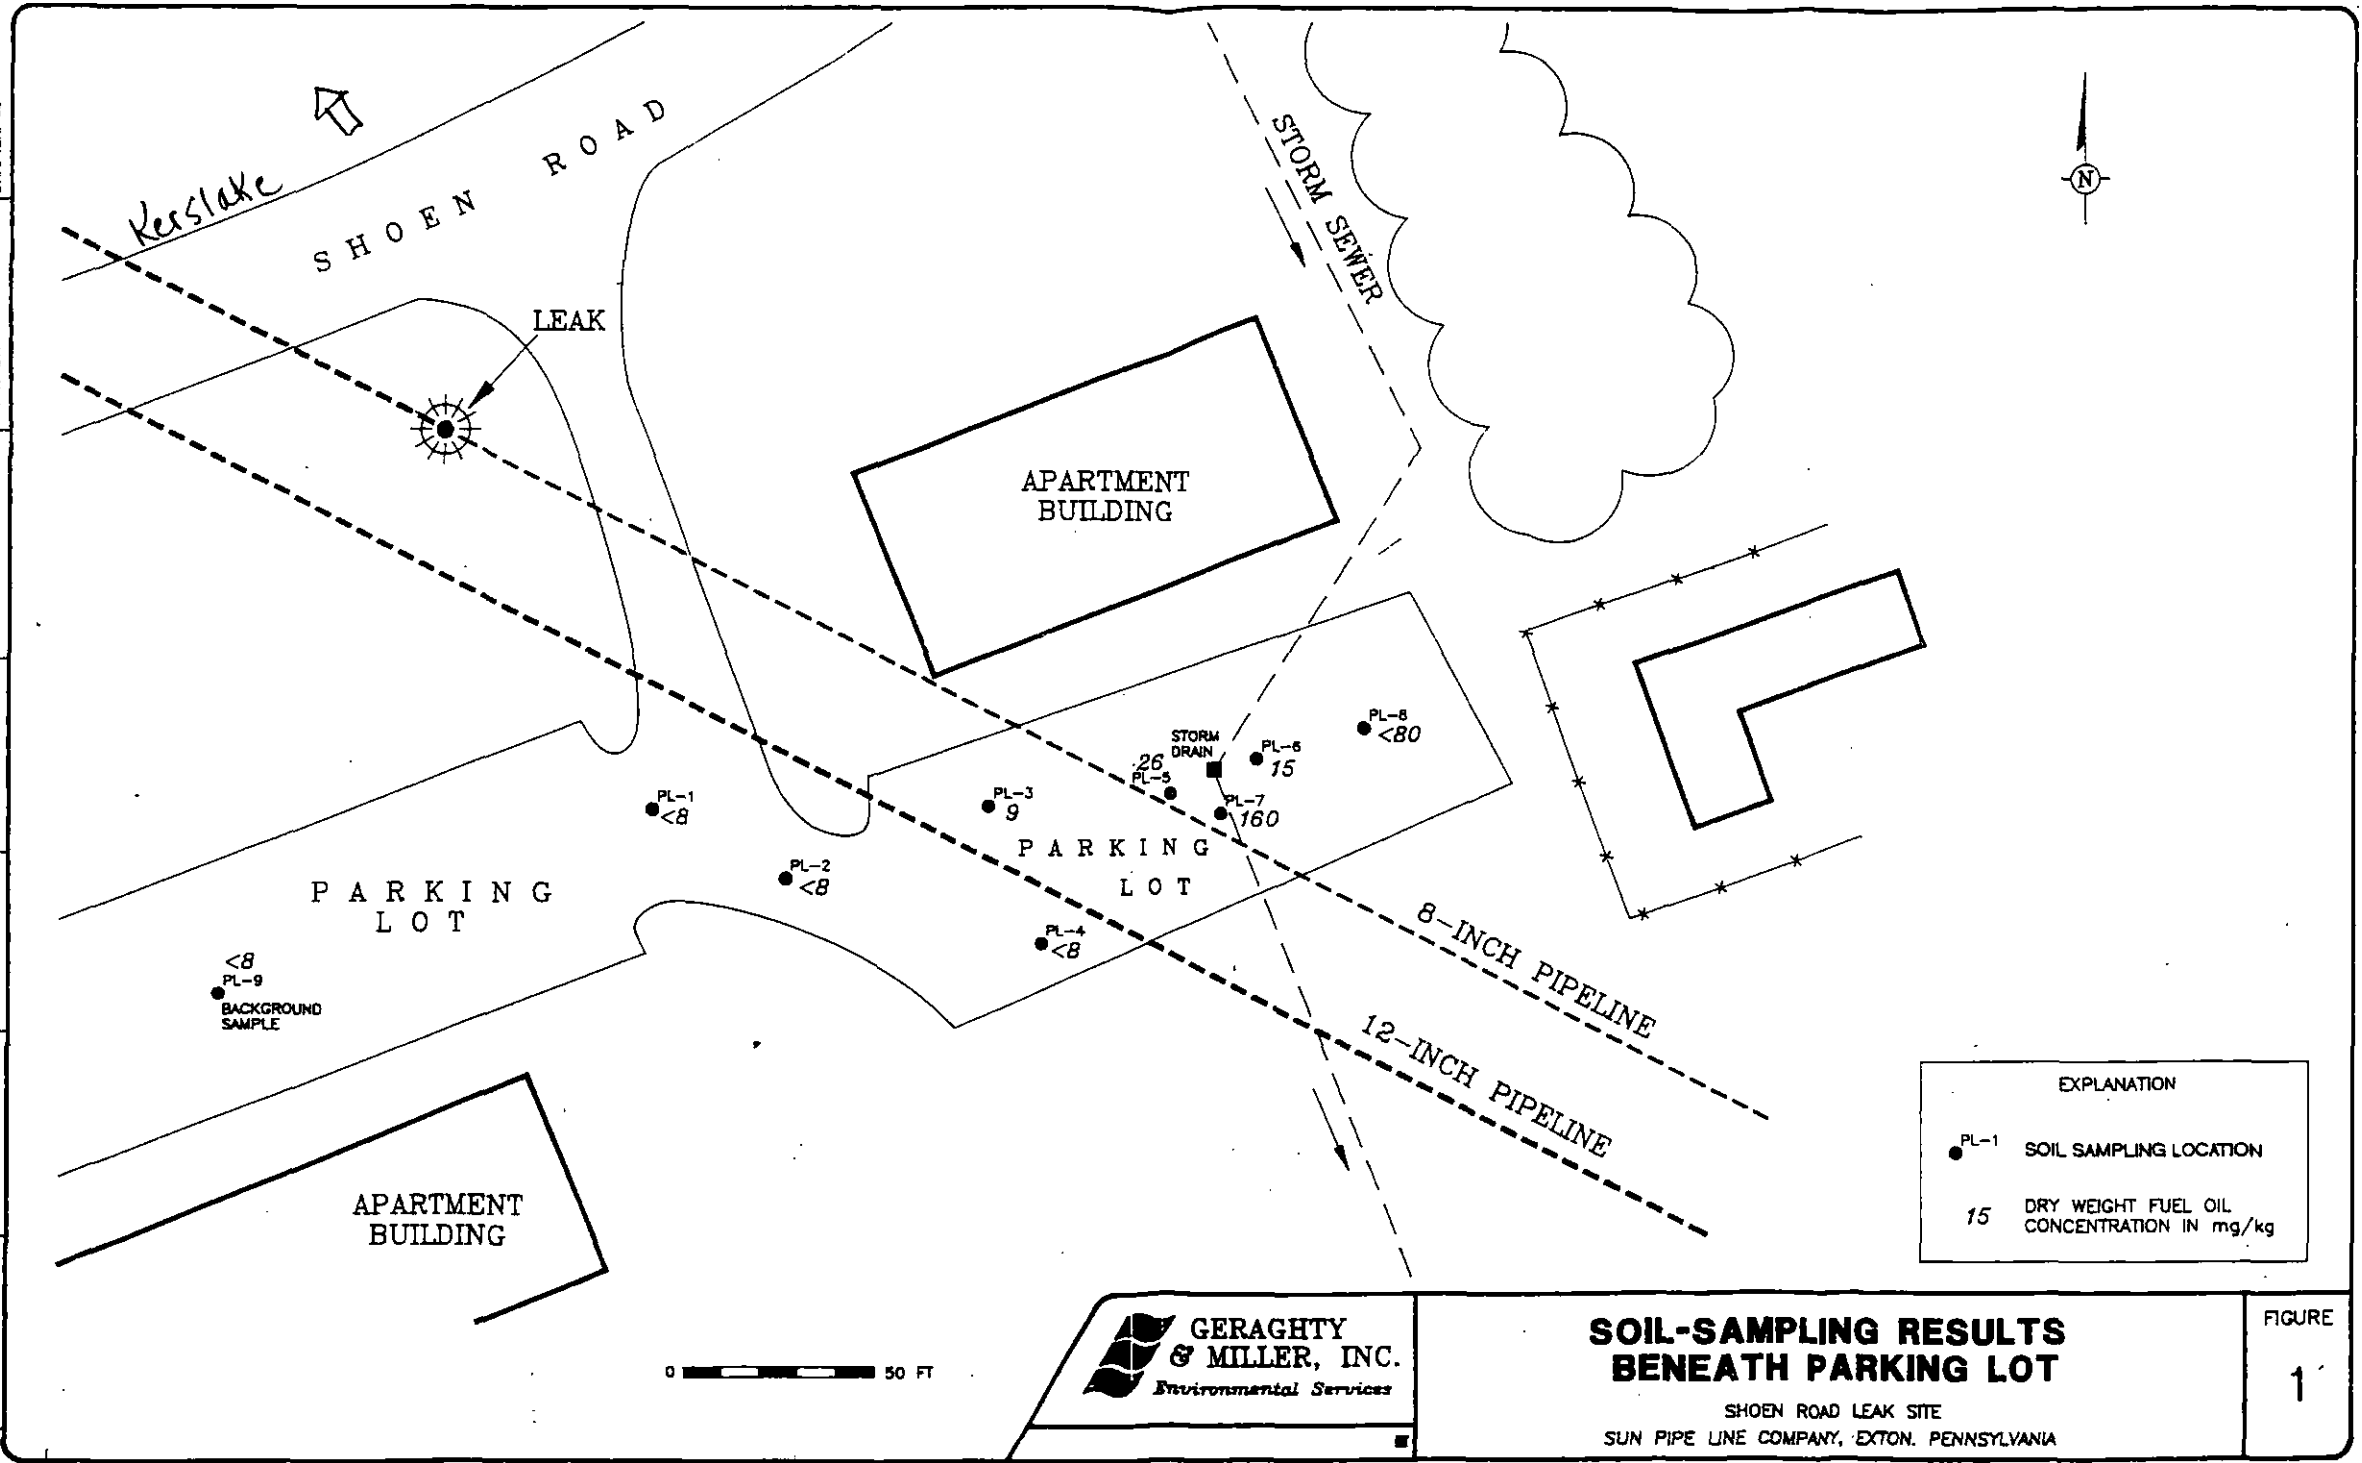
On February 5, 1993, Geraghty & Miller collected eight soil samples immediately below the asphalt road base of the potential impacted parking lot. Sample locations were chosen to best evaluate the soil below the area of past product migration and around the central storm drain. A background sample, PL-9, was collected in a neighboring parking area unaffected by the leak.

None of the samples were saturated with No. 2 fuel oil. A petroleum odor was noted during the collection of sample PL-7. The remaining samples were free of petroleum odor.

- Eight of the nine samples collected beneath the parking lot are free of contamination or contain fuel-oil concentrations less than PADER Level B Interim Guidance Protection Levels for the cleanup of virgin fuel contaminated soils. The remaining sample contains No. 2 fuel oil at 160 mg/kg as compared to the 100 mg/kg Protection Level.
- Additional protection to the ground-water and surface-water resources is provided by the clayey nature of the soil under the parking lot and leak site since clay is capable of immobilizing any residual fuel-oil deposits.

Geraghty & Miller recommends that no further soil investigation or cleanup activities be performed below the asphalt parking lot at the Shoen Road Leak Site.
