**Re: PPL Electric Utilities Corporation  
Quarterly Reliability Report for the  
Period Ended March 31, 2011  
Docket No. L-00030161**

**PPL Electric Utilities Corporation  
Quarterly Reliability Report  
to the  
Pennsylvania Public Utility Commission**

*April 2011*

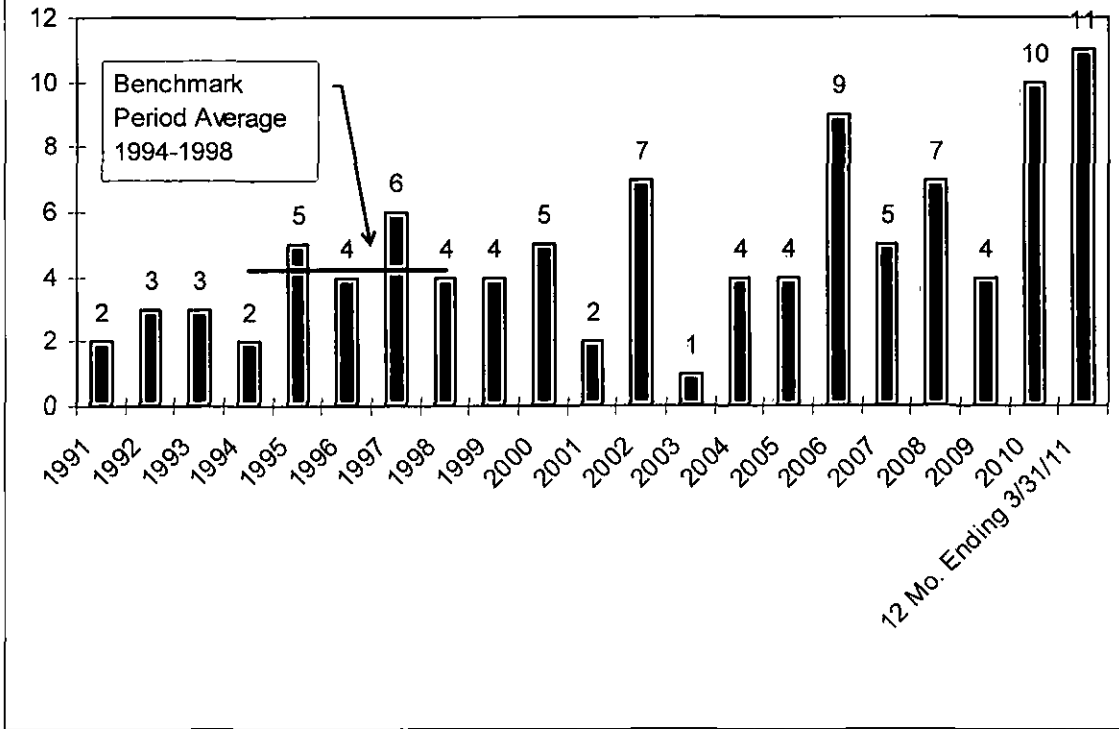
### Storms - PUC Reportable Except Major Events

During the 1st quarter, there were three (3) PUC-reportable storms ( $\geq 2,500$  customers interrupted for  $\geq 6$  hours) and three (3) other storms that required the opening of one or more area emergency centers to manage restoration efforts. Current storm experience remains high compared to historical norms.

Specifically, during the 12-month reporting period, there were eleven (11) PUC-reportable storms ( $\geq 2,500$  customers interrupted for  $\geq 6$  hours) other than major events.

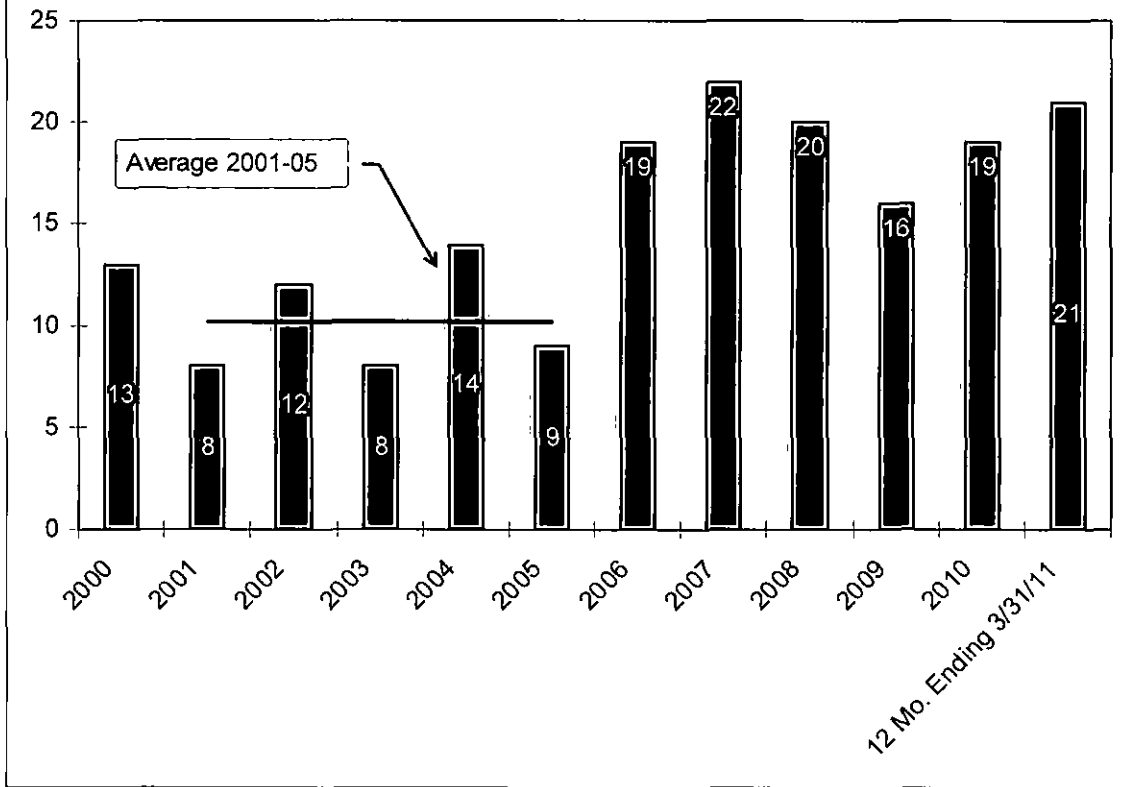
### Storms - Not PUC Reportable

In addition, there were twenty-one (21) storms that were not reportable, but which did require the opening of one or more area emergency centers to manage restoration efforts. This is 106% higher than the average of 10.2 storms per year for the five years from 2001 through 2005.
