**TO:** Larry Gremminger, Christopher Embry – Sunoco Pipe Line Project/Energy Transfer  
**FROM:** David Demko PG – Groundwater and Environmental Services, Inc. (GES)  
**CC:** Lieschen Fish PG, Rick Wardrop, Stephanie Grillo – GES  
**DATE:** November 7, 2019  
**PROJECT NAME:** ME2 – Spread 6 – HDD S3-0360-16 (Devon Rd/ Shoen Road 16-inch pipeline, PA-CH-0199.0000-RD)  
**SUBJECT:** Restart Report for Groundwater Flowback Discharge at HDD S3-0360-16

This Revised Restart Report has been amended to respond to verbal and email comments/requests for information from the Pennsylvania Department of Environmental Protection (PADEP) to the initial report dated October 21, 2019. The initial report was prepared in accordance with the terms and conditions of Paragraph 3.h. of the Consent Order Agreement between Sunoco Pipe Line Project (SPLP) and the PADEP dated July 24, 2017, concerning drilling operations at HDD S3-0360-16 (Devon Rd/ Shoen Road). This Revised Restart Report proposes changes in HDD operations to mitigate groundwater flowback that occurred at varying rates as the drill was advanced.

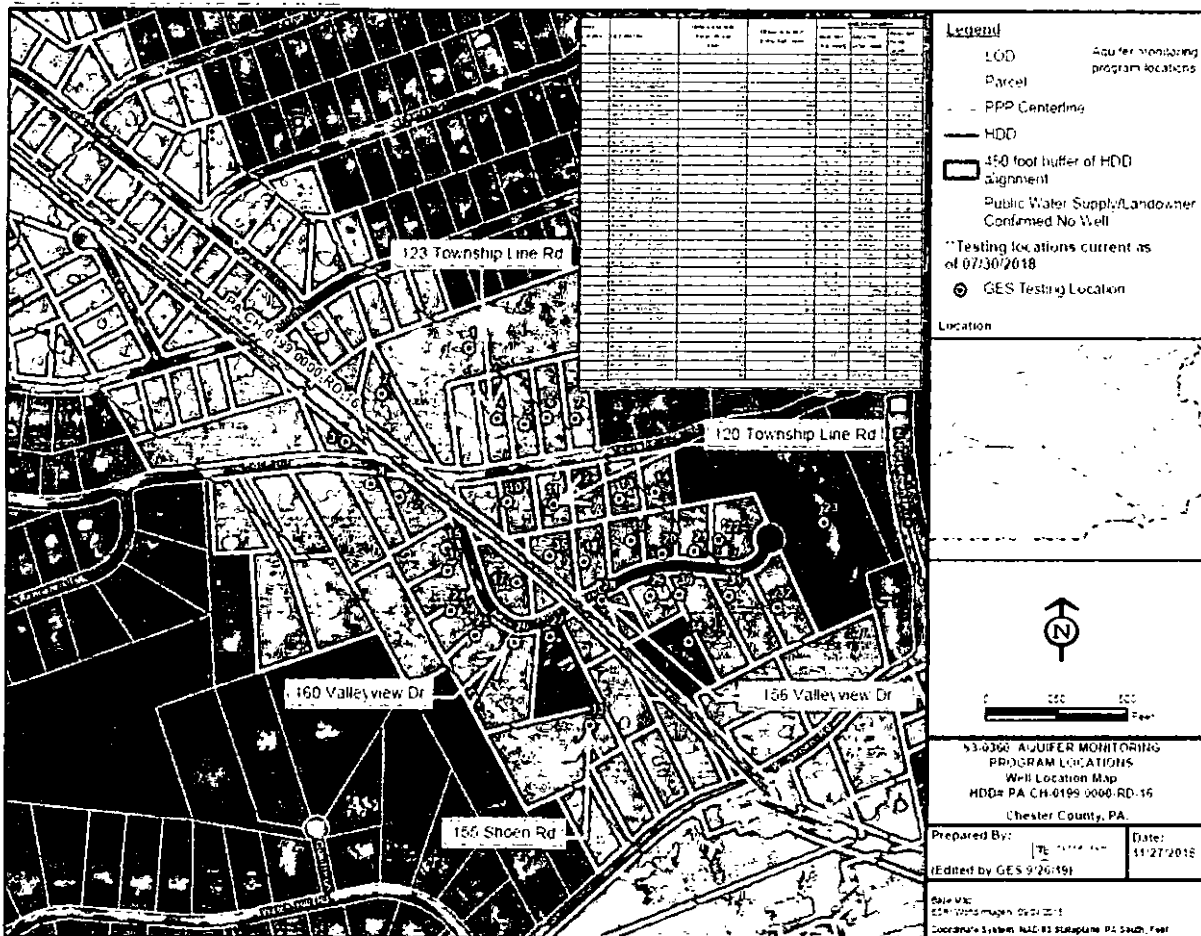
Road, 156 Valleyview Drive, and 160 Valleyview Drive (see annotated **Plan and Profile** above and **Aquifer Monitoring Well Locations Map** below).

Monitoring of the groundwater levels began in December 2017 and the data were downloaded weekly until the start of current drilling activities at HDD S3-0360. A real-time data logger was installed in the 160 Valleyview Drive monitoring well on October 18, 2019, and the remaining four transducers are monitored twice daily (data downloaded and reviewed), during active drilling. The increased monitoring frequency is intended to provide on-going and updated information about the aquifer in the vicinity of HDD S3-0360, particularly regarding the water table conditions at the remaining domestic well being used within the 450-foot buffer zone at 158 Valleyview Drive. The landowner of this domestic well has refused connection to the offered public water supply (see **Attachment B** for a timeline of recent communications with Mr. Mano). The monitoring wells at 156 Valleyview Drive and 160 Valleyview Drive (on either side of 158 Valleyview Drive), and at 120 Township Line Road (slightly upgradient from 158 Valleyview Drive), are well-positioned to indicate immediate influences of drilling activities on the aquifer conditions at 158 Valleyview Drive. The monitoring wells at 123 Township Line Road (upgradient on the water table) and at 155 Shoen Road (downgradient on the water table) are suitable locations to monitor for background conditions possibly influenced by drilling activities, but not affected by pumping and well use at 158 Valleyview Drive.

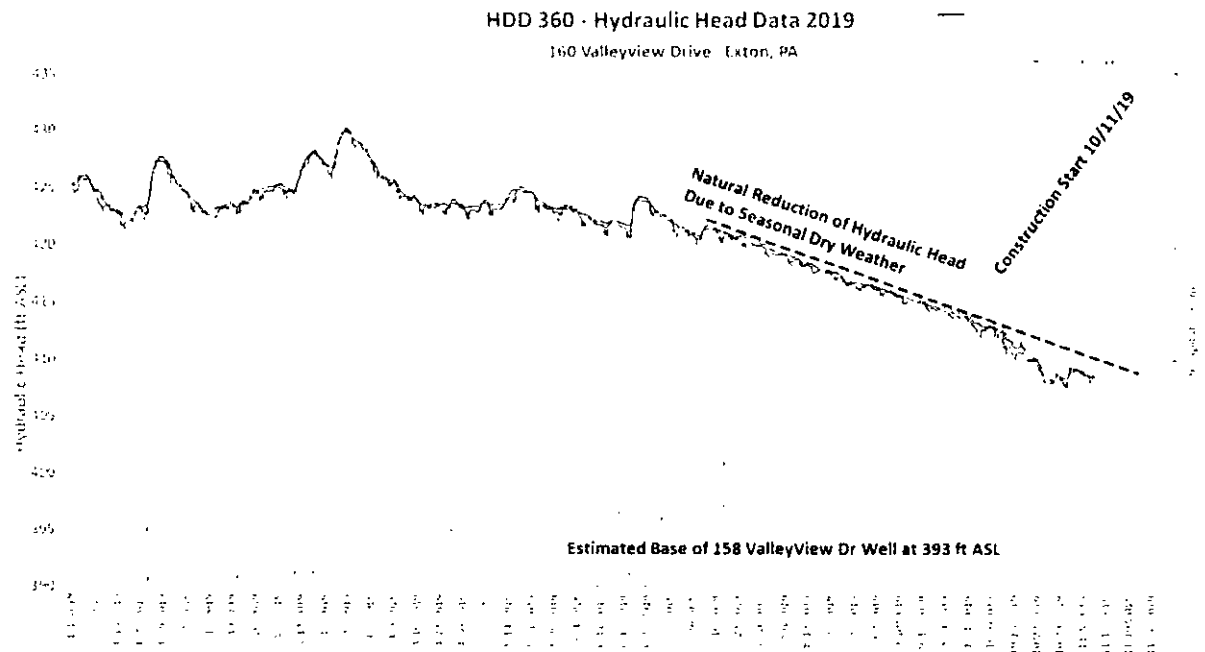
The 158 Valley View Dr well is not to be used as a close analog to the HDD 360 well. Water level measurements of the 158 Valley View Dr well during routine sampling on October 11 revealed that the hydraulic heads of these two wells are generally within 0.5 ft of each other. Moreover, the 158 Valley View Dr well records drawdown and recovery each time the pump is used in the 158 Valley View Dr well, providing additional evidence that these wells are similar in hydraulic response. The following equipment pressure transducer installed in the 158 Valley View Dr well is being monitored routinely and is now programmed to trigger an alarm if the hydraulic head drops below a threshold value in future days.

Subsequently, if water level monitoring detects a significant decrease in water level compared to the natural fluctuations of the two wells, please inform all PADEP and all interested groundwater system (exchange) stakeholders immediately. Feel free to contact me to discuss any questions. Thank you.
