**Re: PPL Electric Utilities Corporation
Quarterly Reliability Report for the
Period Ended December 31, 2011
Docket No. L-00030161**

**PPL Electric Utilities Corporation
Quarterly Reliability Report
to the
Pennsylvania Public Utility Commission**

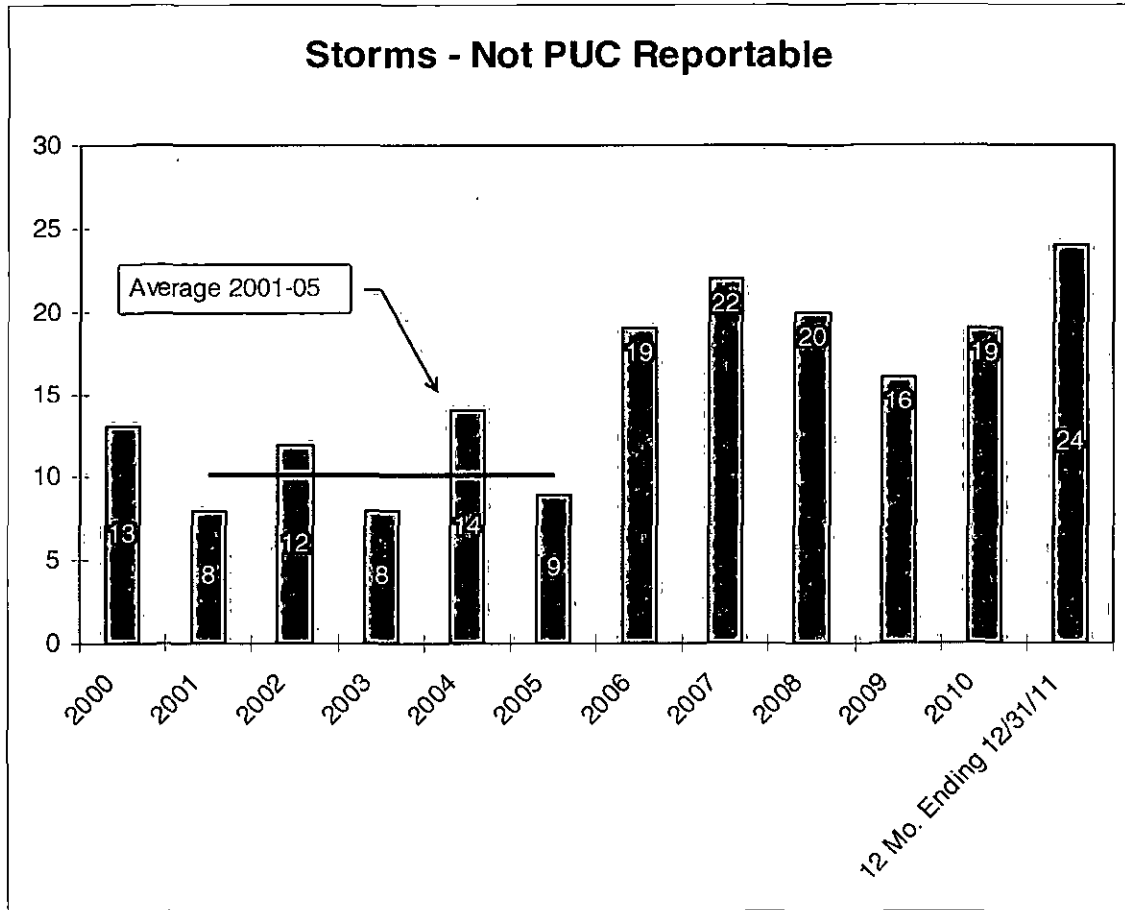
In addition, there were twenty-four (24) storms that were not reportable, but which did require the opening of one or more area emergency centers to manage restoration efforts.
